Bangladesh – India Friendship Power Company (Pvt.) Limited
(A Joint Venture of NTPC Ltd and BPDB)

Monitoring of environment parameters and implementation of Environmental Management Plan during pre-construction and construction period along with Engineering Activities for site development of Khulna 1320 MW Coal based Thermal Power Plant

Third Quarter Monitoring Report of Second Year (2015)

August 2015 – October 2015

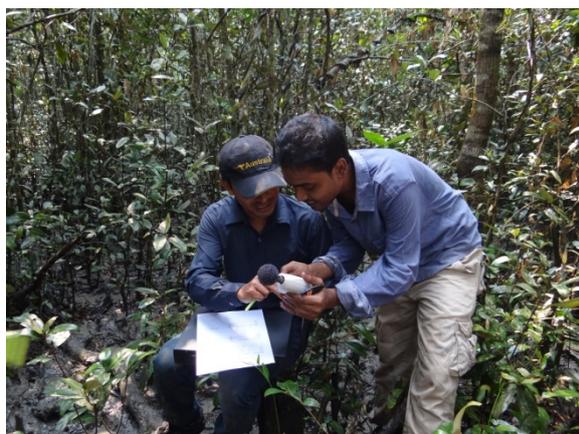
Photo 4.1: Specialists calibrating and setting up noise meter at site before use

30. Noise levels were measured thrice in a day (morning, afternoon and evening) in each of the eleven (11) locations selected for noise monitoring. Each time noise level was recorded for a five minutes time span with a 30 second interval by using portable noise level meter. Each time the noise meter was set up and calibrated depending on the site condition and acoustic environment, following the manufacturer's instruction manual.

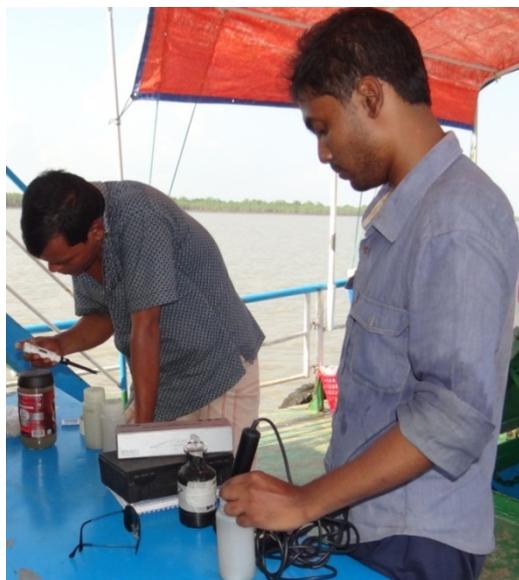
Photo 5.1: On-spot Water Quality parameters test at Harbaria

54. Sampling of surface and groundwater has been conducted following the standard methodologies and practices. The study area is highly influenced by tidal variation. Hence, temporal and spatial variations of tides have been considered significantly in sampling procedure. The standard sampling procedure maintained in pragmatic manner which would

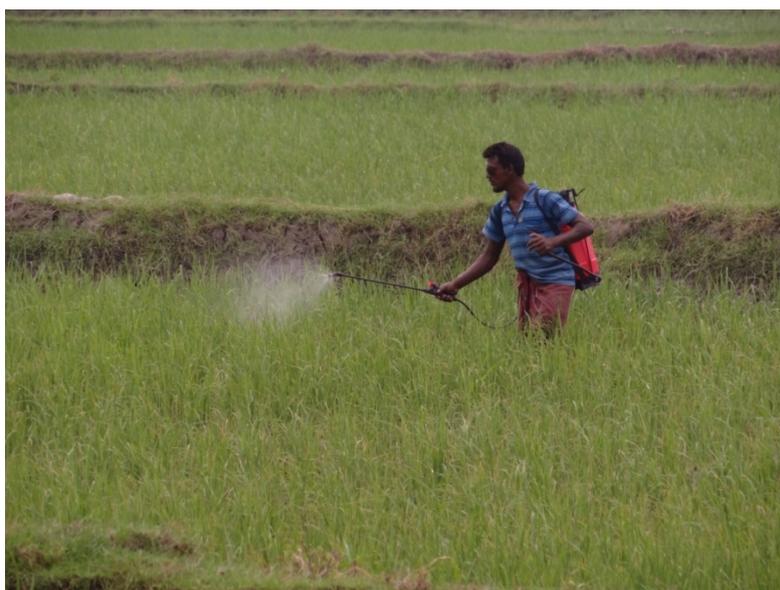
Photo 7.2: Use of pesticide in monitoring agriculture land at Basherhula

106. Farmer of the respective plot cultivated HYV Aman (BR23) in this Kharif-II season (2015-16). Chemical fertilizer and liquid pesticides are being used in the land for crop production. Pest like Stem borer and Leaf roller infestation observed in his land. Chemical fertilizer and pesticides are being used in the land for crop production. Chemical fertilizer used the following rate in his land, Urea: 15.0 kg/plot, TSP: Not applied and MP: 5.0kg/plot. To protect crop from pest infestation liquid pesticide Virtako applied @ 60ml/plot. Detailed cropping pattern is shown in the **Table 7.2**

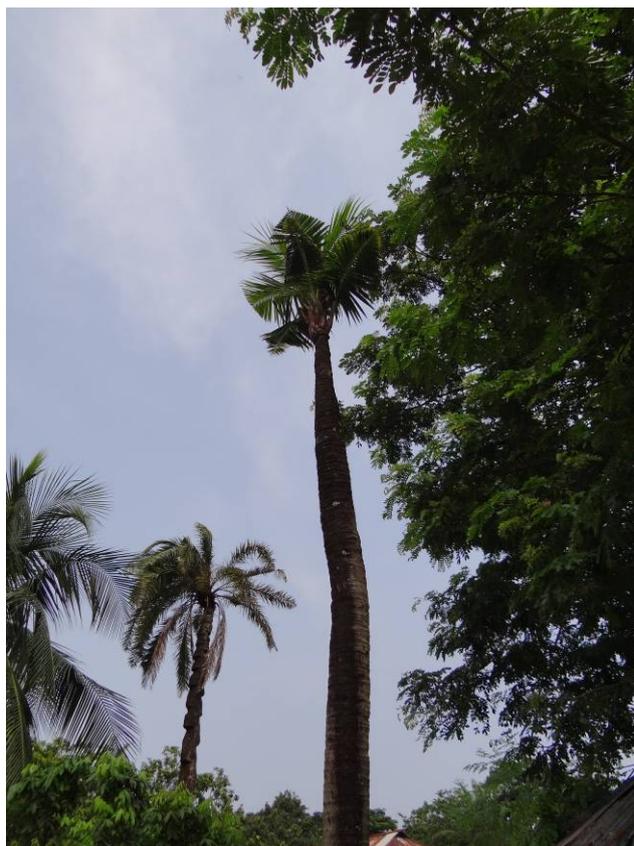
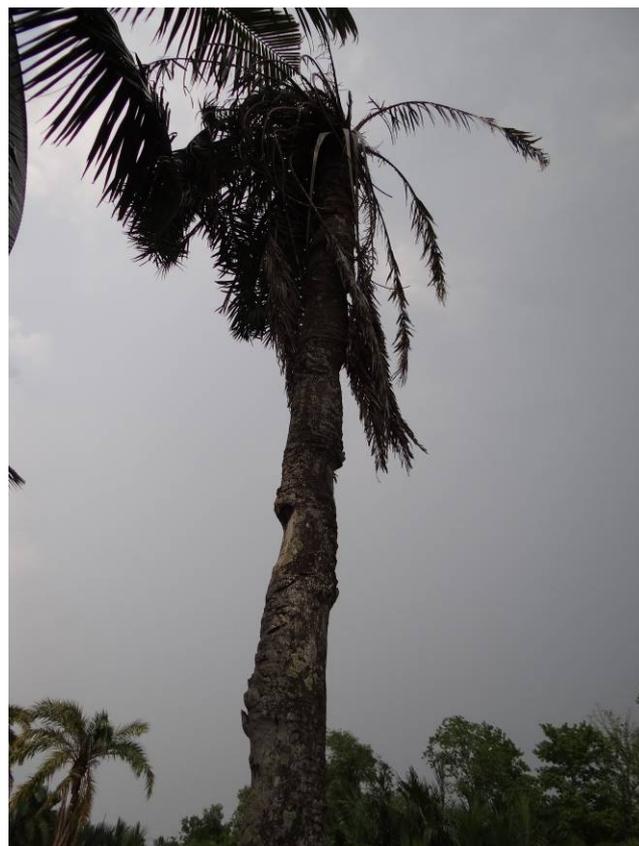
Photo 9.2 : Unhealthy coconut and date palm plant at studied homesteads in Rajnagar (Left) and Chalkghona (Right)

166. Leaf spot, leaf blast, nut fall, Mite damage on nut fruit are common diseases of the plants in the study area. A brief discussion was held with home owners about diseases of selected economic plants which exist in their homesteads. Most symptoms for plant diseases are descriptive. Although, all plant diseases symptoms are not visible at a same time of the year, but it was tried to observe the existing disease symptoms. Leaf spot and mite damage on fruits is the common symptoms of *Cocos nucifera*. In addition, bud/trunk rot, lethal yellowing and diameter loss at top portion of this monocot is also common symptom of this plant in all location. Fungal/ bacterial infection is not remarkable in the homesteads. But Leaf Anthracnose on *Mangifera indica* and Bacteriosis on *Psidium guajava* is commonly found most of the trees. *Phoenix sylvestris* also found unhealthy due to leaf yellowing from manganese deficiency.

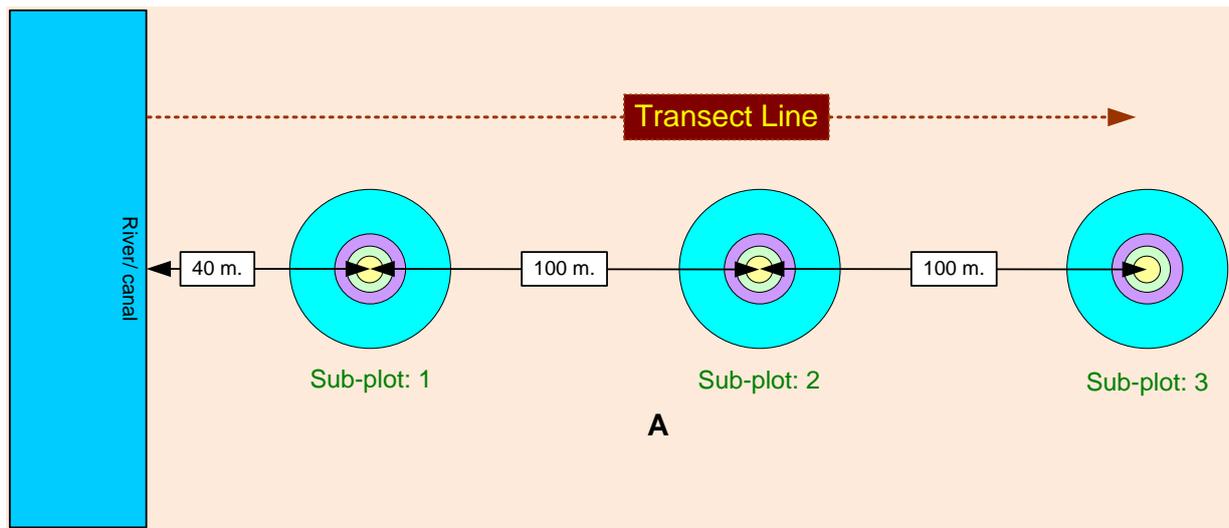
Figure 10.1: Layout of the subplots and transect line perpendicular from ecotone (river or canal bank)

185. In each site, a transect line was laid out perpendicular to river or canal bank. Along, the transect line three circular nested subplots of 12.62 m radius were laid out at 100 m intervals in order to capture maximum tree species (Figure 10.2). Because of the variation in species composition in SRF observation plots were laid out from coast, river or canal side to landward zone (forest proper side). The location of the first subplot was 40 m away from ecotone (riverside) to inner ward of forest in order to save the subplot from river bank erosion.

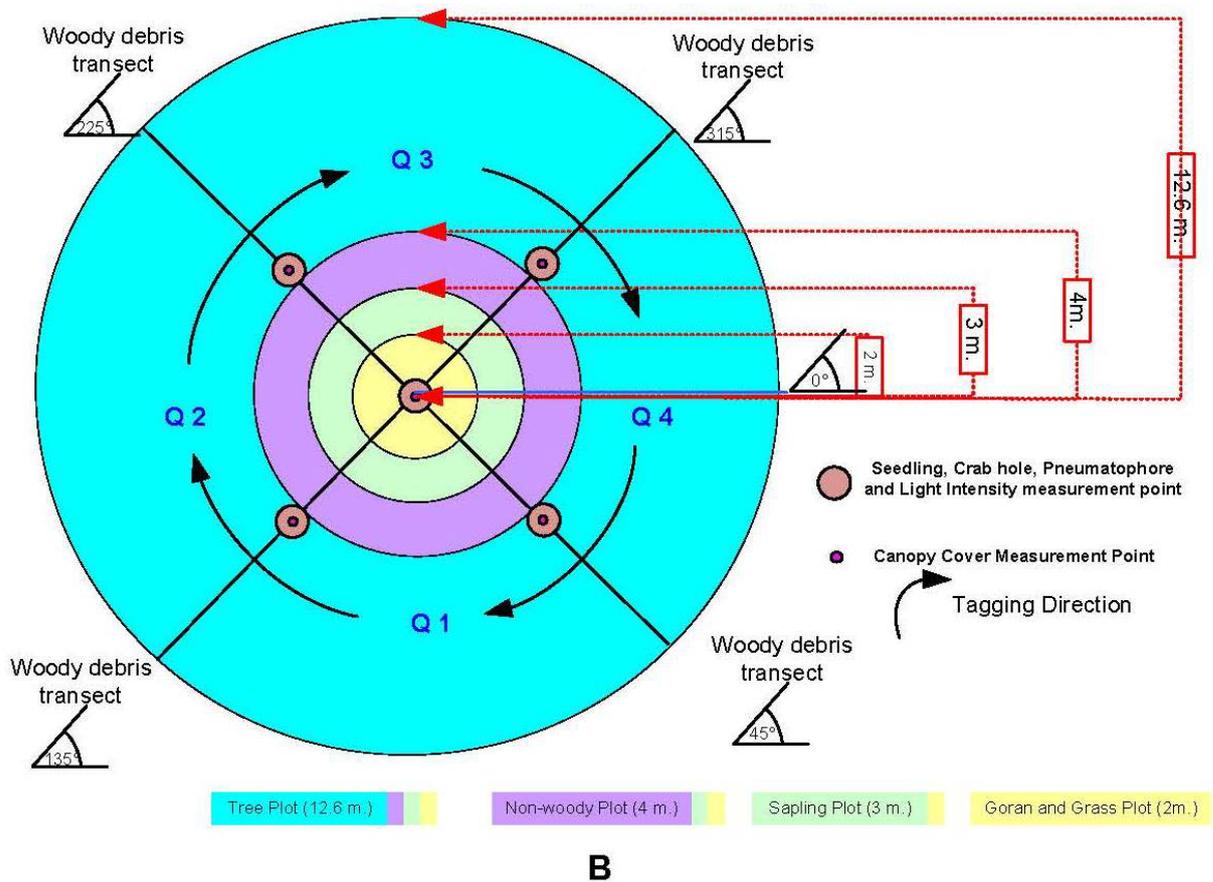
Figure 10.2: Layout of the survey activities in each subplot

190. Crab plays important role in mangrove ecosystems such as decomposing litter fall thereby increasing fertility. In order to work out the crab density, usually crab hole abundance is monitored. For this purpose, in this study the crab hole were counted within an area of 1 m radius circle in each subplot's centre and in the midpoint of four woody debris transects (**Figure: 10.2**).

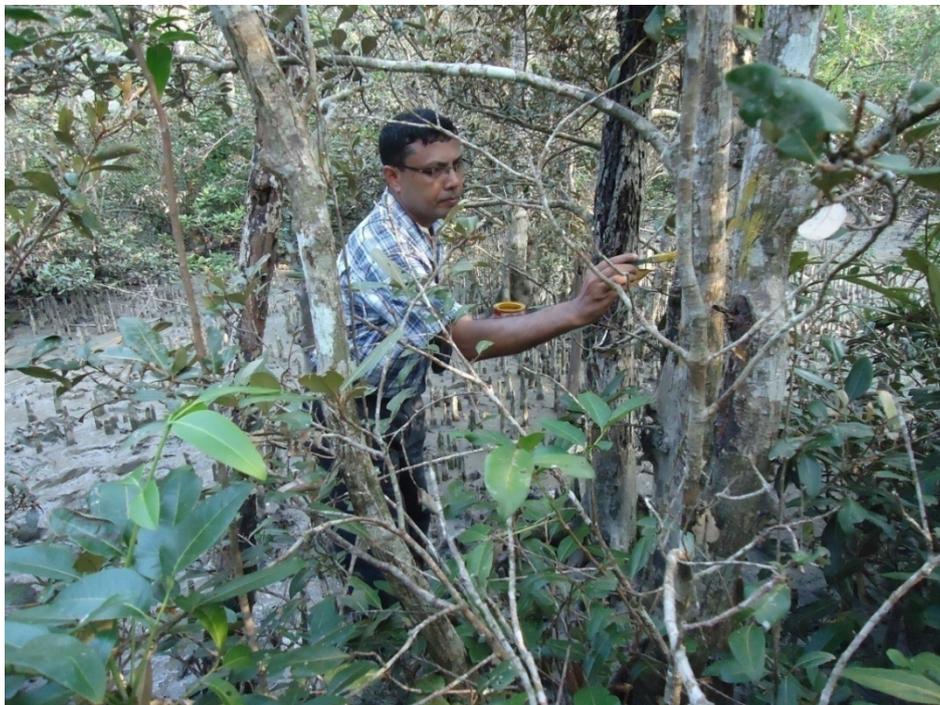
Photo 10.1: CEGIS Professionals checking tree tag number and painting marks on different trees in the quadrate of subplot

186. The tag number of trees (DBH \geq 5cm and lean angle greater than 450) was monitored and rewritten if any shade was found within 12.62 m radius circle of Permanent Sample Plot (PSP).

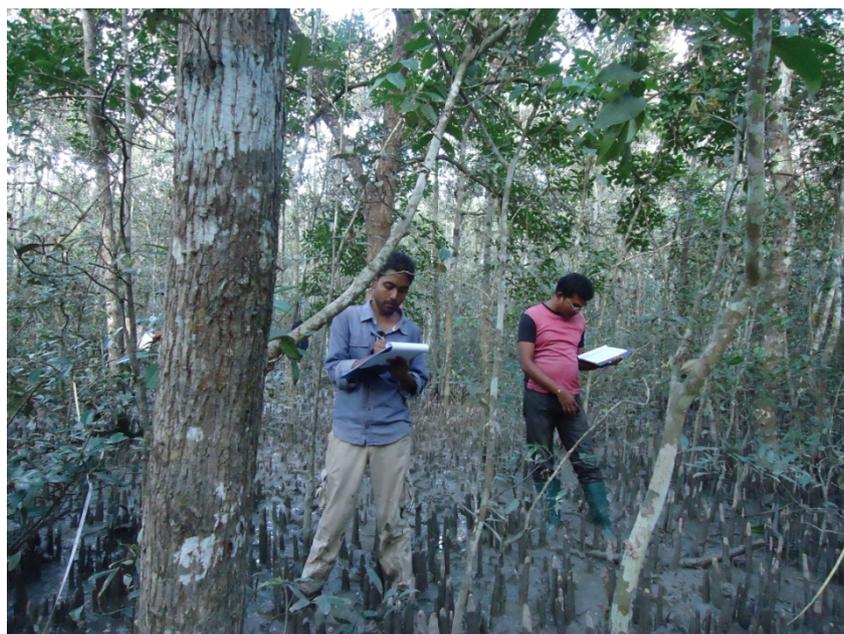
Photo 10.4: Surveyor counting pneumatophore on forest floor in the subplot

189. Pneumatophores, the specialized root system in mangrove plays a vital role in root respiration by gas (oxygen) exchanging in this anaerobic condition of mangrove. During tidal inundation especially in the rainy season the forest floor goes under water. At five points of each of the subplots, within a circular area of 1 meter radius around each point, the total number of pneumatophores was recorded with its living status. The first one was laid out in the centre of each subplot and other four were in the midpoint of the four woody debris transects that were facing at 45°, 135°, 225° and 315°.

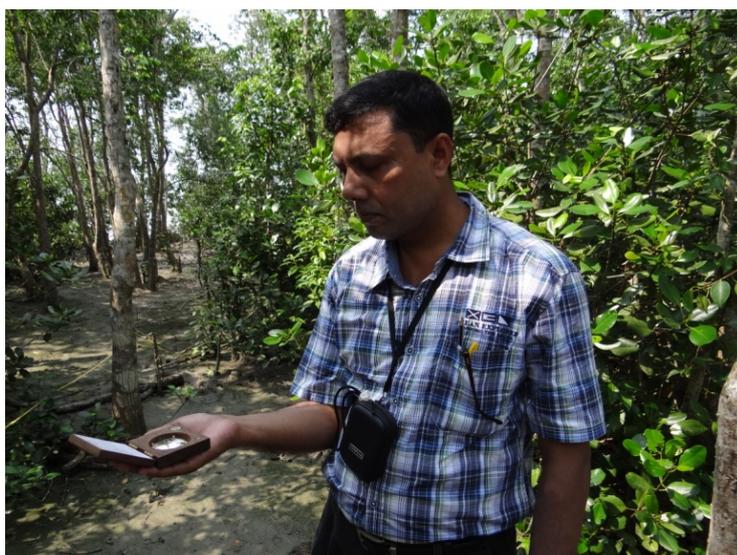
Photo 10.7: Crew member taking canopy cover percentage

192. Percentage (%) of canopy cover was estimated by a spherical densiometer which is a grided convex mirror that provides a simple and inexpensive approach of measuring canopy cover. The densiometer was held at a distance of 30–40 cm in front of the body and at an elbow height, so that head is not visible in the mirror. After levelling the instrument using the level bubble, the dots not occupied by canopy was systematically counted. In each subplot, the readings were taken at five points facing at north, south, east, and west direction including subplot centre point. First one was taken standing at subplot centre and the other four were taken at the middle point of the four transects between centre and periphery. The canopy cover was estimated by taking the average of these five readings.

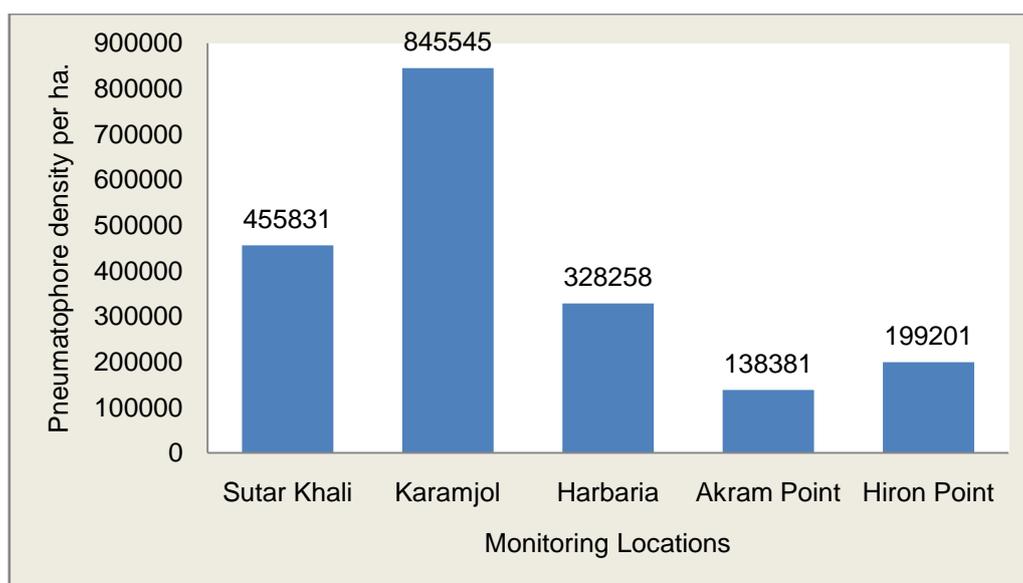
Figure 10.5: Mean pneumatophore density per ha. in the monitoring plots (PSPs) for 2nd year 3rd quarter monitoring

194. The mean density of pneumatophores has not significantly varied during the sixth monitoring periods in all of the study sites (Figure. 10.6). In the monitoring, it is usually found that Karamjal is mainly dominated by Baen tree, and it has numerous tender pneumatophores that usually dry up and die during dry season. For this reason, in this site, the pneumatophore density was found higher than the other sites (Figure. 10.5). The forest health study sites are mainly dominated by Sundri-Gewa-Goran tree species. In general, the mean pneumatophores density is found lower in number in Akram point and Heron point due to floristic composition (Gewa tree dominated).

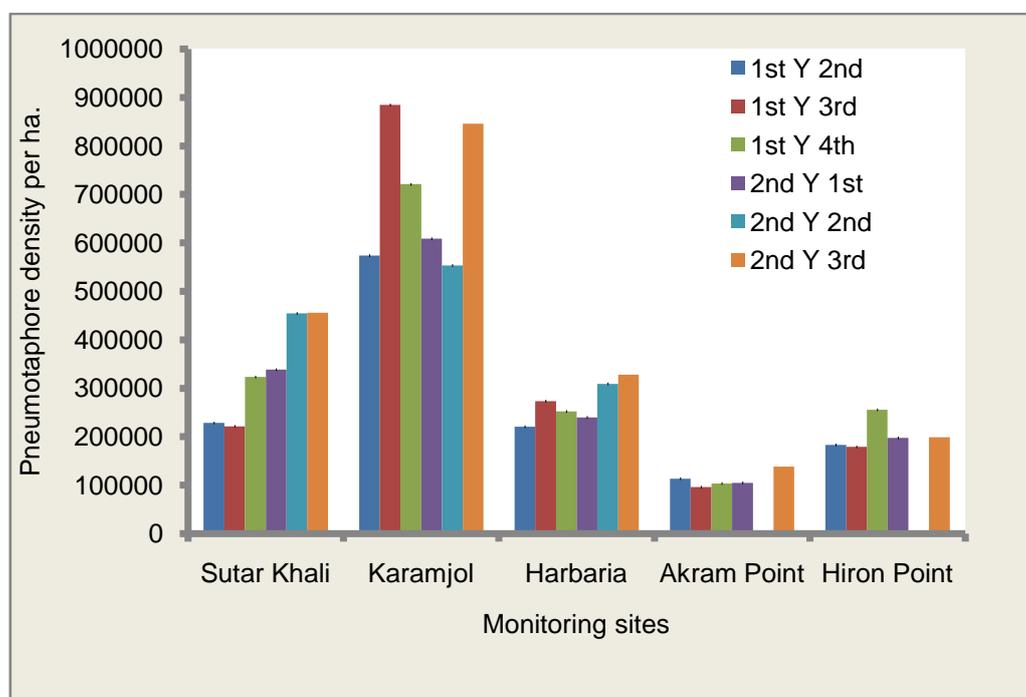
Figure 10.6: Mean pneumatophores density per ha. among the quarterly surveys in five monitoring sites

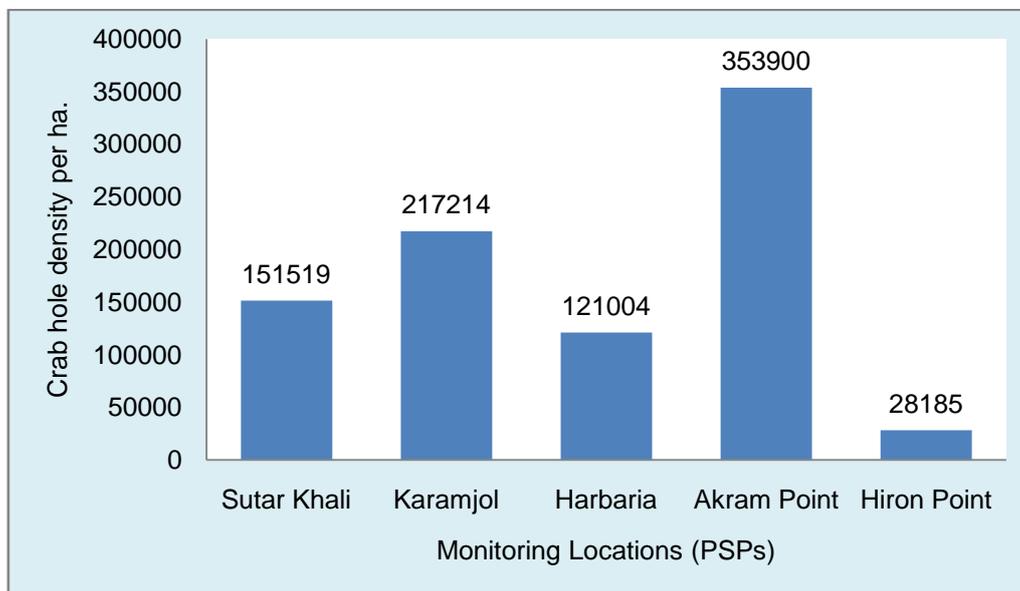
Figure 10.7: Mean crab hole density per ha. in the monitoring plots (PSPs) for 2nd year 3rd quarter monitoring phase

195. The crab hole density per hectare (the indicator of availability of crab in a site) has significantly varied among all the five monitoring sites (Figure 10.8). This result indicates that food chain has remained good in all the monitoring sites as crabs are the primary consumers of fallen leaves on forest floor that are source of nutrients in soil. The numbers of crab hole were found highest in Akram point and lowest in Hiron point (Figure 10.7).

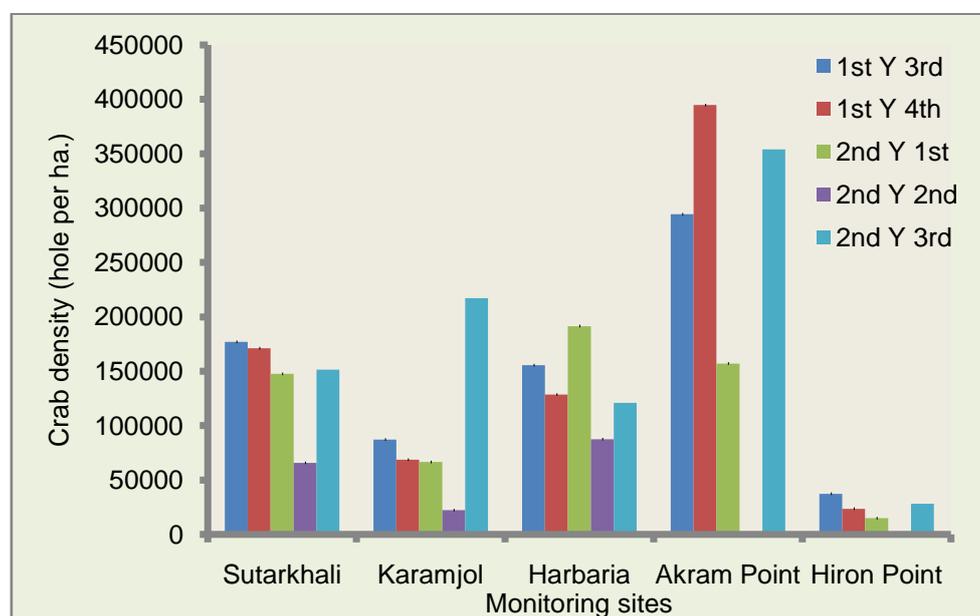
Figure 10.8: Mean crab hole density per ha. among the quarterly surveys in five monitoring sites
