Bharat Heavy Electricals Limited

Monthly Monitoring Report - 4 (July, 2018)

Environment Compliance Monitoring During Construction Period of 2x660 MW Maitree Super Thermal Power Project Rampal, Bagerhat

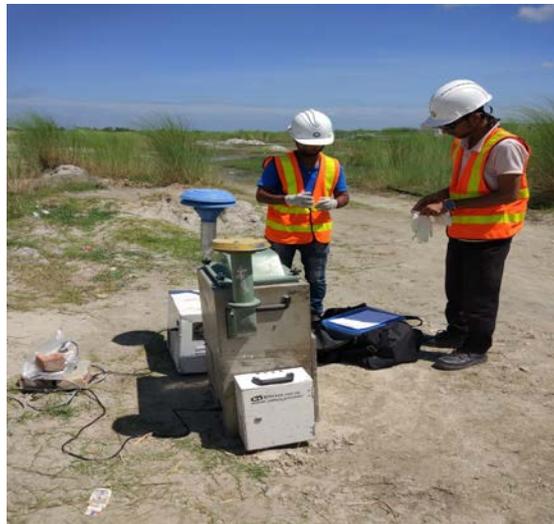
Figure 3.1: Ambient Air Quality Monitoring

Air quality has been sampled through volumetric sampling procedure. Sample has been collected for 24 Hours continually at three places especially at the site of labour shed, Jetty area and major construction areas. All of the criteria pollutants have been checked randomly in the Project site in order to assess the baseline situation as well as for the compliance standard. **Table 3.1** shows the monitoring results of the criteria pollutants.

Ambient air quality for the pollutant gases has been recorded to be well below the standard limit during this month. Presence of criteria pollutants in ambient air quality at labour shed and Jetty location were recorded lower than previous month but slightly higher at major construction area. Increasing activities at the construction yard were responsible for rising the pollutants concentration. Regular monsoon rainfall reduces over pollutants in the ambient air quality of the project area. However, the potential sources of air pollutants at the time of sampling for 24 hrs presented below.

- Massive construction activities
- Exposed/uncovered soil of the Project site.
- Land development activities of BPDB site.
- Construction works like piling, soil compaction, testing, building construction and other civil works etc.
- Vehicular movement over the paved and unpaved roads inside the Project area.
- Operation of generators and different types of machineries.
- Stockpile of sand, stone, debris etc.

Land development and excavation works of the Project site. Since maximum project works are limited to day time, the pollutants increases during day time and reduces during night time. Therefore, the collective pollution concentration for each of the criteria pollutants represent the average values for 24 hrs. Moreover, frequent rainfall is also responsible for washout of air pollutants of the Project air shed. However, the ambient air pollutants were found within the standard limit as set by the DoE. The Project authority should take further necessary action, such as, use of dust musk for the labour during working at the construction site.

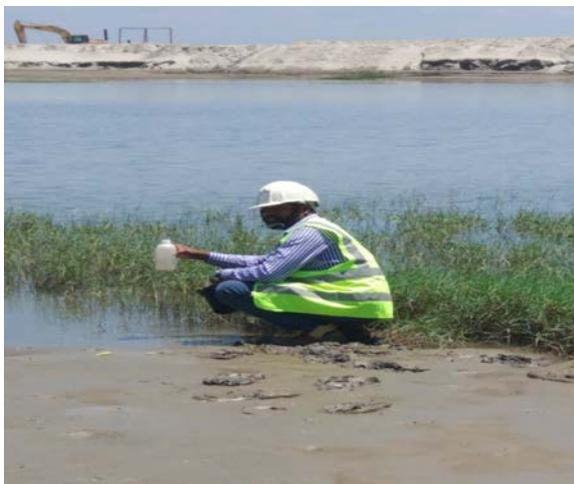
Figure 3.2a: Storm Discharge Water Sample Collection

At present, a number of temporary drainage network are being developed for discharging storm water into the adjacent river. During the dry days, this storm water are re-used for sprinkling or curing purpose. As mentioned earlier, during this 4th monitoring program three samples were collected, one from RO technology based Water Treatment Plant discharge outlet, one from storm water discharge outlet and one from drinking water outlets from BHEL project office for analysis.

Rainfall runoff from the project site is noted as storm water discharge. It contains project site washout i.e. solid waste, liquid waste. No national or international standard has been fixed for storm water discharge quality. Since, this storm water was released from the Project Site, the standard for effluent has been used for compliance. **Table 3.3** shows the storm water discharge quality. EC and TDS value of storm water discharge have been found higher than the standard values (ECR 1997). Discharge of RO technology based Water Treatment Plant nearby BHEL office, mixing with Passur river water may be the reason for increasing the EC and TDS values. Increasing the chloride concentration in storm water implies the mixing of river water with the storm water discharge.

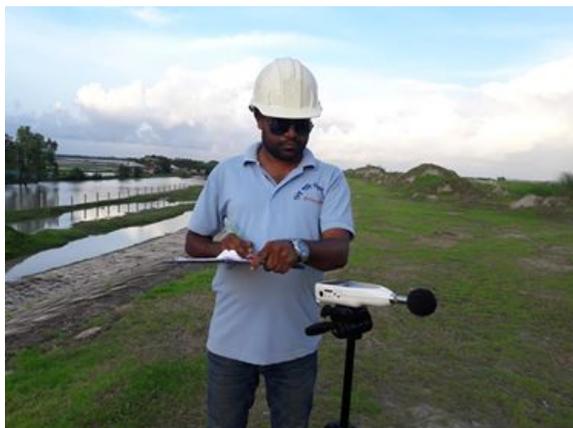
Figure 3.3: Ambient Noise Level Monitoring during Day Time

Massive civil construction activities and mechanical construction are being carried out by BHEL as per design and stipulated time schedule. The sources of noise has been identified and presented in Table 3.5. The construction activities, vehicular movement, running of generator, Crain activities, for soil compaction machineries, Excavators activity and wind blowing are major sources of noise generation. As seen from the above Table that the overall noise level at the construction areas was higher at few places than the previous month except BIFPCL Office premises. It has been observed that the noise level for the major construction areas and labour shed areas were reflecting slightly higher noise level with respect to the national and international standard limit. Massive construction works are responsible for increasing noise level at construction yard which is definitely limited within the project boundary. Construction of labour camp is responsible for increasing the noise level at the labour camp area. Proponent was informed about this and suggestions were given to implement the use of ear-muffs by the labourers during construction activities.
